National Dioxin Study Tier 4 - Combustion Sources: Quality Assurance Evaluation

EPA-450/4-84-014f
January 1986

National Dioxin Study Tier 4 — Combustion Sources

Quality Assurance Evaluation

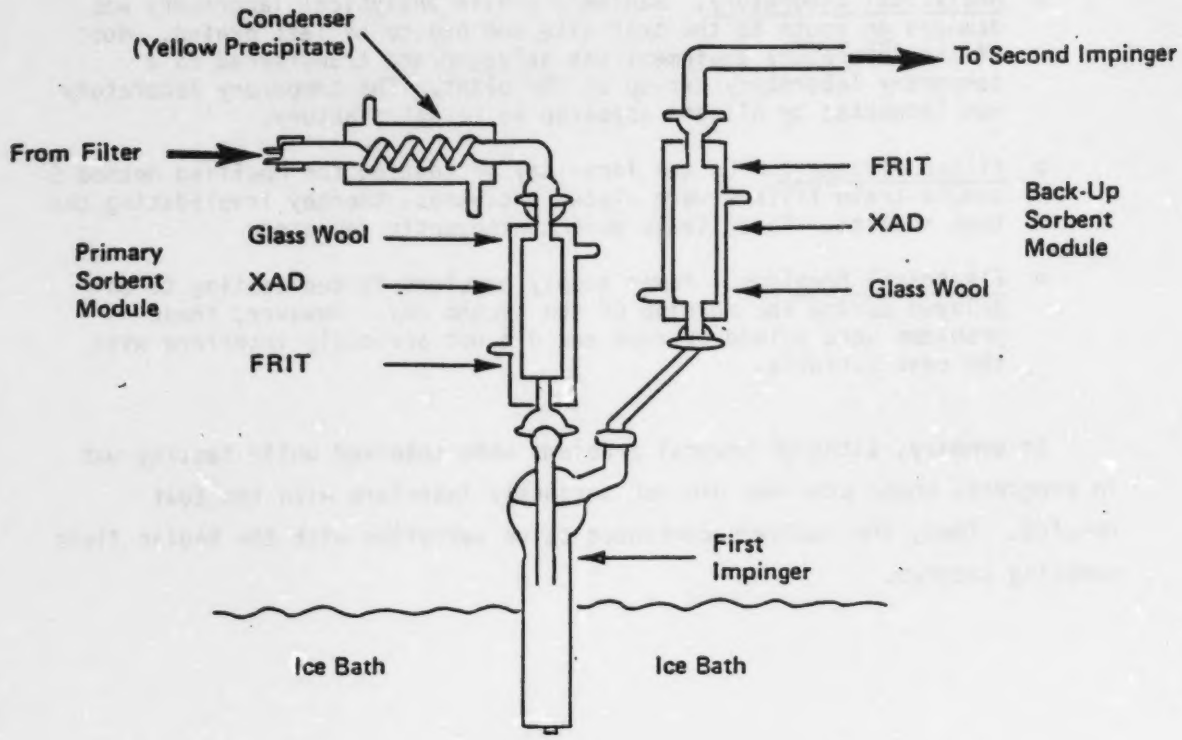
Figure 1. Configuration of primary and back-up sorbent modules in Modified Method 5 sampling train.

The Modified Method 5 sampling train in use at the Site MET-A tests was unique in that a second XAD resin cartridge was added to the system just after the first impinger, as illustrated in Figure 1. This configuration, which was requested by EPA, was designed to mitigate concerns regarding the horizontal position of the XAD condenser. (Although the horizontal mounting of the condenser had been approved by EPA during previous Tier 4 tests, officials from a State Agency remained concerned about an increased potential for organic compounds breaking through the resin.) The set-up and operation of the second XAD resin cartridge appeared to be acceptable. Furthermore, with one exception, operation of the entire train appeared normal. The one exception involved the formation of a yellow precipitate in

the condenser, between the filter and the first XAD resin cartridge. The nature of this precipitate is unknown, although its color suggests it may be chloride. Radian reported that the precipitate was easily removed with acetone.
